**Flood Control Project Maintenance  
Levee Inspections**

**Fall 2014 Levee Maintenance Deficiency Summary Report**

**Sacramento River Basin**

**Reclamation District No. 0010 Honcut**

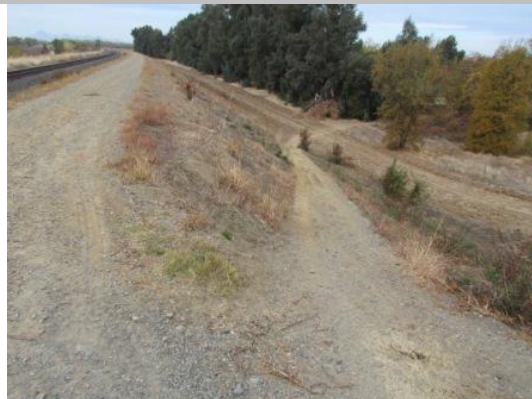
Photo 1 of 1 : FA\_2014\_RD0010\_163\_48\_20141020\_00003.jpg

LM Start	0.71	Rating **	M	Issue No.	48
LM End	0.71	Issue Type +	Ob	Location *	LS
Category	Earthen Levee			GPS Latitude/Longitude	
				Start	End
Item	Slope Stability			39.161198 °	39.161198 °
				-121.597102 °	-121.597102 °
DWR ID	DWR_RD0010_01_f_2013_48				
Action/Comments					
Repair the levee slope damaged by vehicle traffic and prevent access where possible.

This photo was taken from the crown looking down the landward slope at an ATV access road that has been formed over time to provide access to the waterward side. Fall 2013.

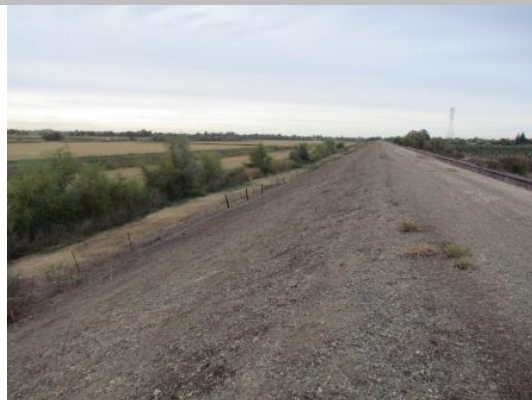
Photo 1 of 1 : FA\_2014\_RD0010\_163\_341\_20141103\_00298.jpg

LM Start	2.34	Rating **	A	Issue No.	341
LM End	2.34	Issue Type +	Ma	Location *	WS
Category	Earthen Levee			GPS Latitude/Longitude	
				Start	End
Item	Vegetation			39.179694 °	39.179694 °
				-121.584516 °	-121.584516 °
DWR ID	DWR_RD0010_01_f_2014_341				
Action/Comments					
Control annual grass and weeds on the levee slopes and easements.

This photo was taken from the crown facing south looking down the waterward levee slope at acceptable vegetation maintenance. Fall 2014.

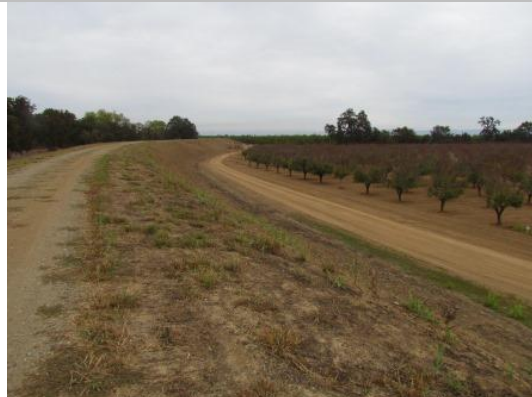
Photo 1 of 1 : FA\_2014\_RD0010\_164\_524\_20141103\_00503.jpg

LM Start	4.33	Rating **	A	Issue No.	524
LM End	4.33	Issue Type +	Ma	Location *	LS
Category	Earthen Levee			GPS Latitude/Longitude	
				Start	End
Item	Vegetation			39.225274 °	39.225274 °
				-121.613502 °	-121.613502 °
DWR ID	DWR_RD0010_02_f_2014_524				
Action/Comments					
Control annual grass and weeds on the levee slopes and easements.

This photo was taken from the crown facing north looking down the landward levee slope at acceptable vegetation maintenance. Fall 2014.

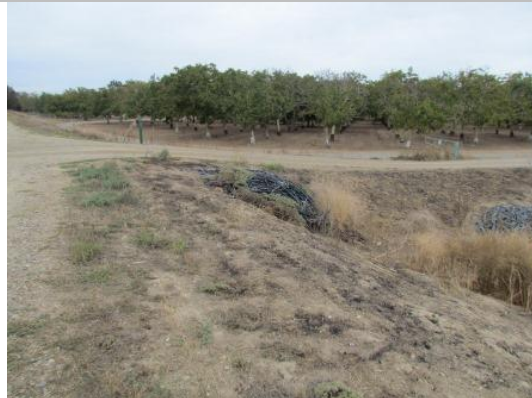
Photo 1 of 1 : FA\_2014\_RD0010\_164\_70\_20141103\_00504.jpg

LM Start	9.36	Rating **	M	Issue No.	70
LM End	9.36	Issue Type +	En	Location *	LS
Category	Earthen Levee			GPS Latitude/Longitude	
				Start	End
Item	Encroachments			39.286826 °	39.286826 °
				-121.600418 °	-121.600418 °
DWR ID	DWR_RD0010_02_f_2013_70				
Action/Comments					
Landscape Irrigation					
Inspector Comments: Irrigation piping on landward levee slope.

This photo was taken from the crown facing north looking down the landward levee slope at irrigation pipe at the toe. Fall 2014.

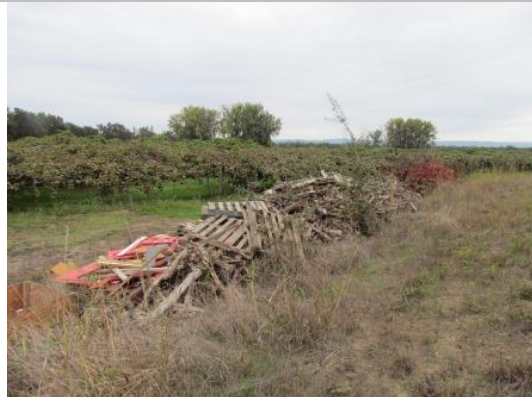
Photo 1 of 1 : FA\_2014\_RD0010\_165\_7\_20141103\_00107.jpg

LM Start	0.19	Rating **	U	Issue No.	7
LM End	0.19	Issue Type +	En	Location *	WS
Category	Earthen Levee			GPS Latitude/Longitude	
				Start	End
Item	Encroachments			39.310189 °	39.310189 °
				-121.615980 °	-121.615980 °
DWR ID	DWR_RD0010_03_s_2014_7				
Action/Comments					
Prunings

This photo was taken from the levee crown facing east looking down the waterward slope at a pruning pile at the levee toe. Fall 2014.

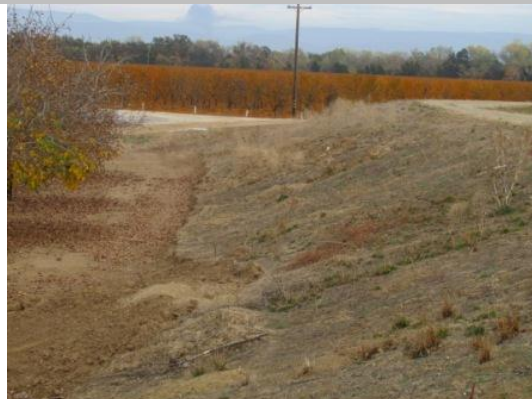
Photo 1 of 1 : FA\_2014\_RD0010\_165\_18\_20141020\_00004.jpg

LM Start	1.85	Rating **	M	Issue No.	18
LM End	1.85	Issue Type +	Ma	Location *	WS
Category	Earthen Levee			GPS Latitude/Longitude	
				Start	End
Item	Slope Stability			39.302904 °	39.302904 °
				-121.588578 °	-121.588578 °
DWR ID	DWR_RD0010_03_f_2013_18				
Action/Comments					
Repair the levee slope damaged by vehicle traffic and prevent access where possible.					
Inspector Comments: Toe cut at edge of waterward side of levee.

This photo was taken from the levee crown facing north looking down the waterward slope at agricultural tilling causing a cut at the levee toe. Fall 2013.

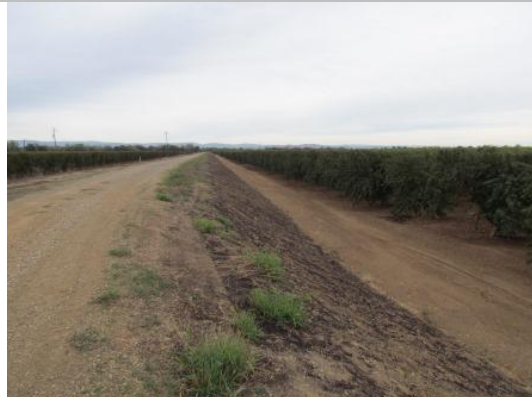
Photo 1 of 1 : FA\_2014\_RD0010\_165\_135\_20141103\_00108.jpg

LM Start	1.93	Rating **	A	Issue No.	135
LM End	1.93	Issue Type +	Ma	Location *	LS
Category	Earthen Levee			GPS Latitude/Longitude	
				Start	End
Item	Vegetation			39.303418 °	39.303418 °
				-121.587260 °	-121.587260 °
DWR ID	DWR_RD0010_03_f_2014_135				
Action/Comments					
Control annual grass and weeds on the levee slopes and easements.

This photo was taken from the levee crown facing east looking down the landward slope at acceptable vegetation maintenance. Fall 2014.
